CONTROL SURVEY MONUMENT RECOVERY

Cathedral City

Number: **102**

Name: **EDOM HILL / VARNER**

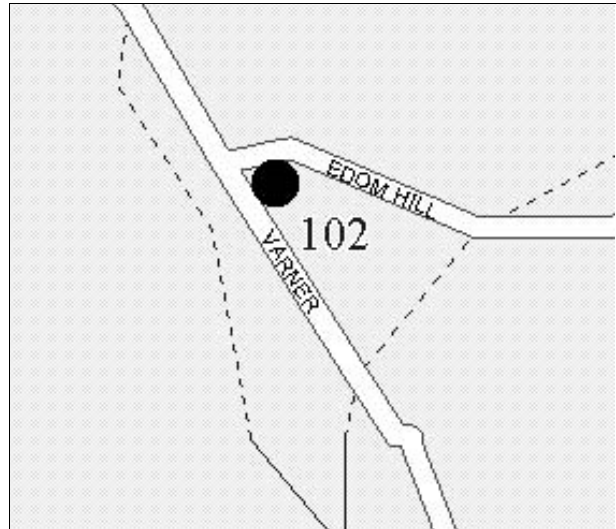
Monument Description: GPS Useable: Yes
Set Cathedral City bronze disk in concrete monument

At the easterly corner of the intersection of Edom Hill Rd and Varner Rd

Approximately 20 ft from edges of pavement
